**AMPCO Parking Lot  
Soil Sample Location Map**  
 Vermiculite Intermountain Facility  
 Libby Sister Site SLC2  
 Salt Lake City, UT

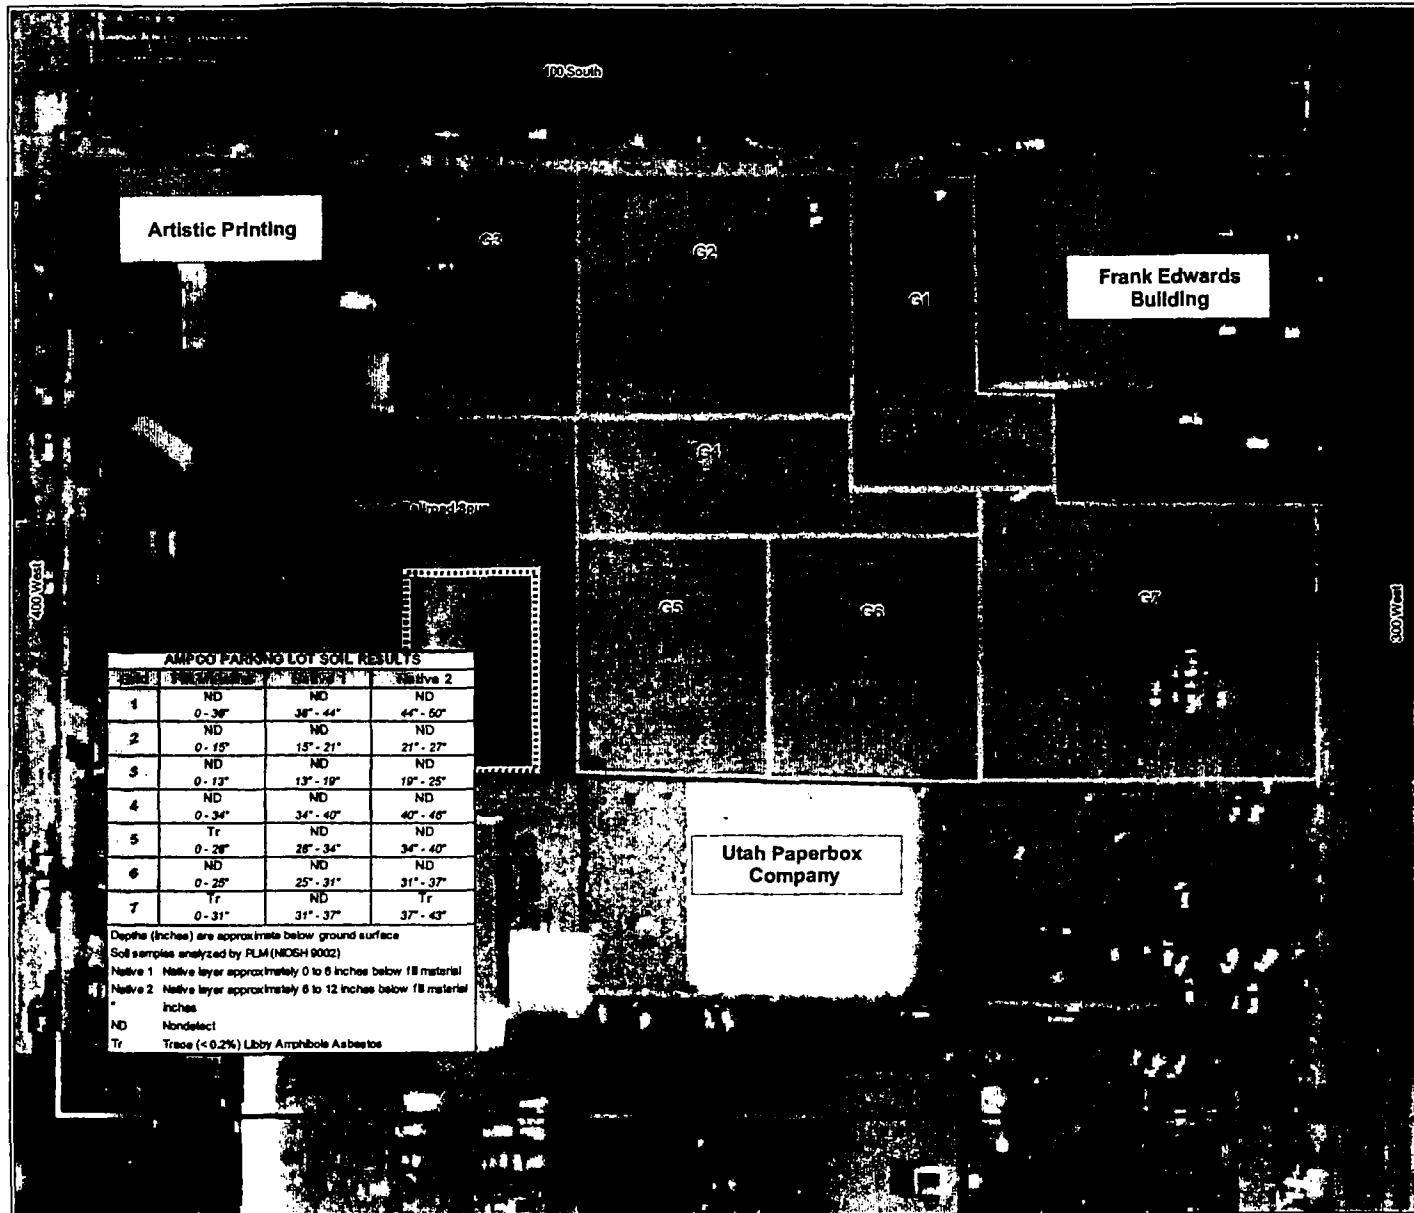
- Approximate Subsample Location
- Approximate Sampling Grid Location
- Building Outline
- Site Boundary
- Approximate Boundary of Former Processing Building

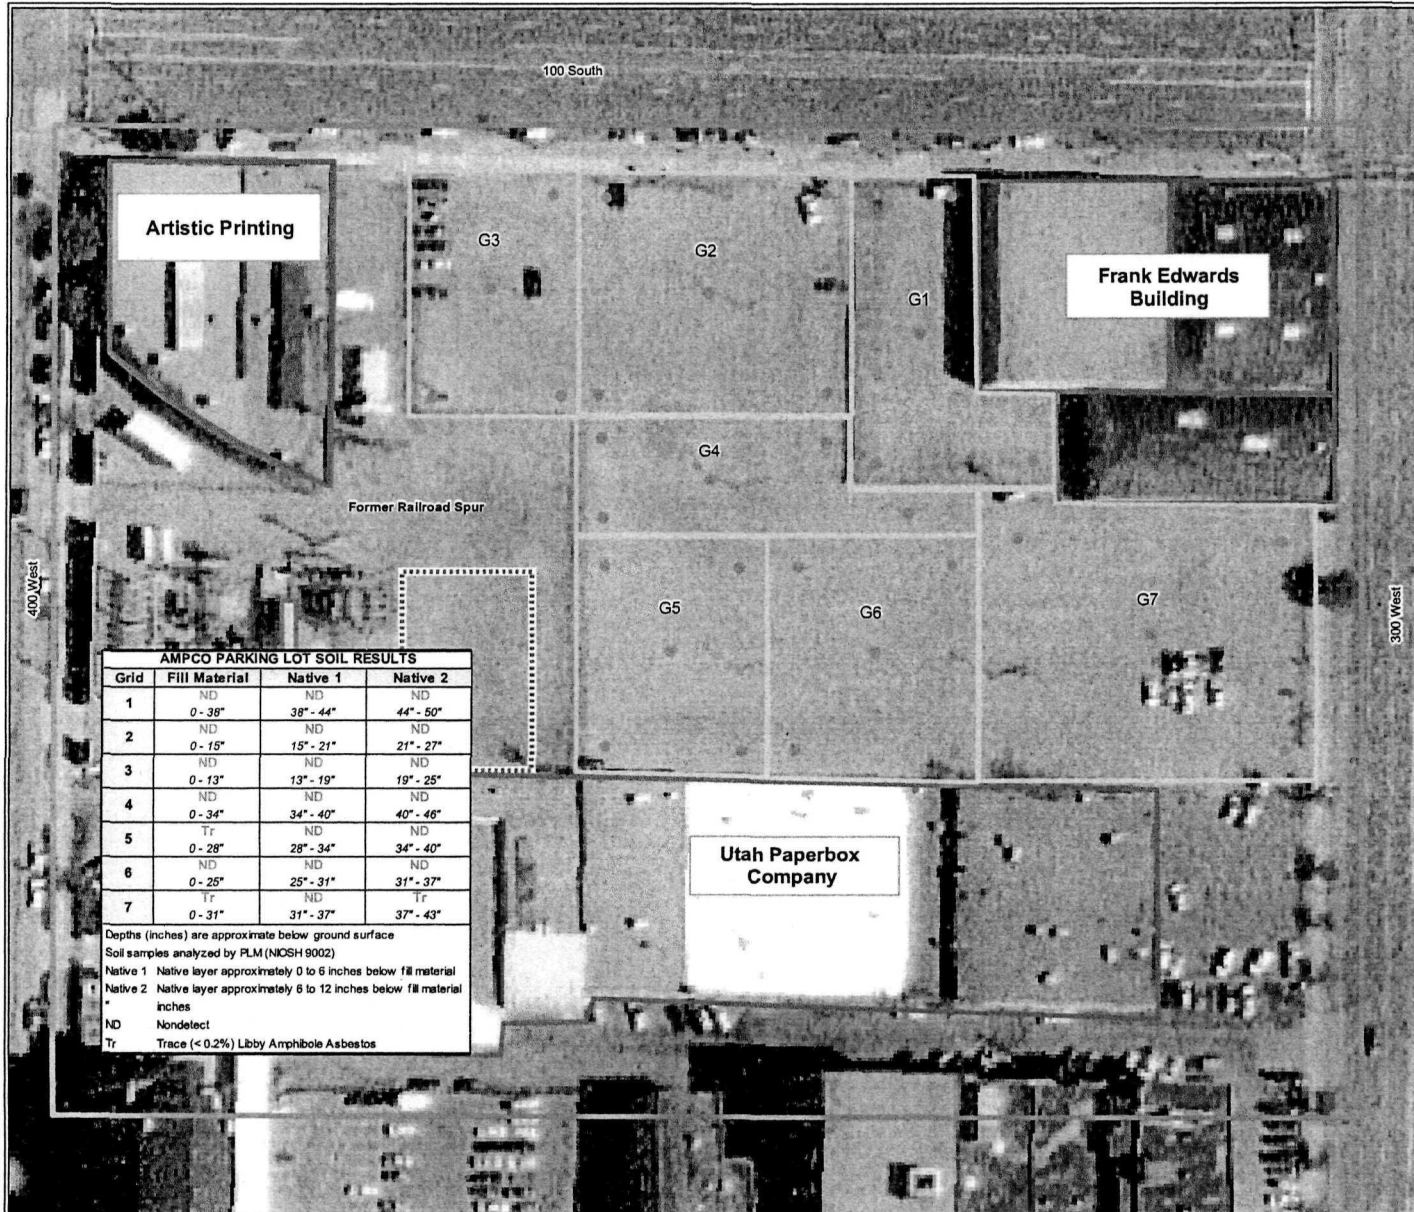
**AMPCO Parking Lot  
Soil Sample Location Map**  
 Vermiculite Intermountain Facility  
 Libby Sister Site SLC2  
 Salt Lake City, UT

AMPCO PARKING LOT SOIL RESULTS			
Grid	Fill Material	Native 1	Native 2
1	ND 0 - 38"	ND 38" - 44"	ND 44" - 50"
2	ND 0 - 15"	ND 15" - 21"	ND 21" - 27"
3	ND 0 - 13"	ND 13" - 19"	ND 19" - 25"
4	ND 0 - 34"	ND 34" - 40"	ND 40" - 46"
5	Tr 0 - 28"	ND 28" - 34"	ND 34" - 40"
6	ND 0 - 25"	ND 25" - 31"	ND 31" - 37"
7	Tr 0 - 31"	ND 31" - 37"	Tr 37" - 43"

Depths (inches) are approximate below ground surface  
 Soil samples analyzed by PLM (NIOSH 9002)  
 Native 1 Native layer approximately 0 to 6 inches below fill material  
 Native 2 Native layer approximately 6 to 12 inches below fill material  
 inches  
 ND Nondefect  
 Tr Trace (< 0.2%) Libby Amphibole Asbestos
